# Manhole Inspection Summary

Manhole # S35K\_\_032MH

Insp Date: **1/22/09 1:27 PM**

**Location** Address: **e. conway st**

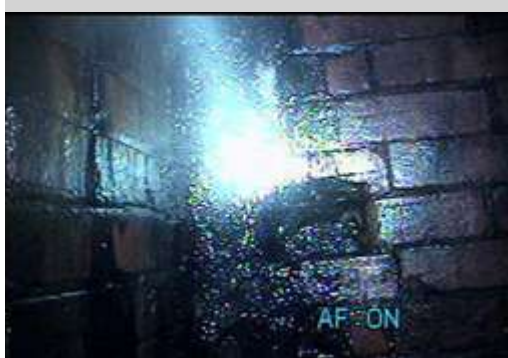
Defect 4

Condition: ☐ Sound ☒ **Cracked** ☐ Root Intrusion ☒ **Loose Brick** ☒ **Deteriorated**

barrel loose bricks

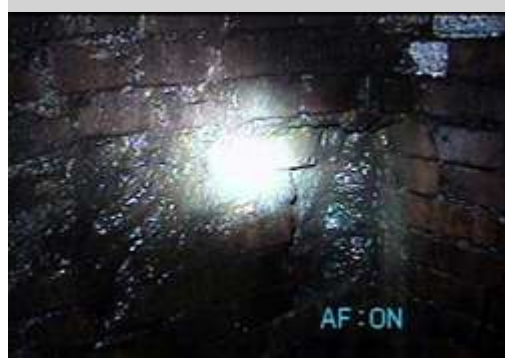
Defect 3

Infiltration: ☐ None ☐ Joint ☒ **Cracks** ☐ Mortar ☐ Roots ☒ **Wall**

barrel infiltration at wall

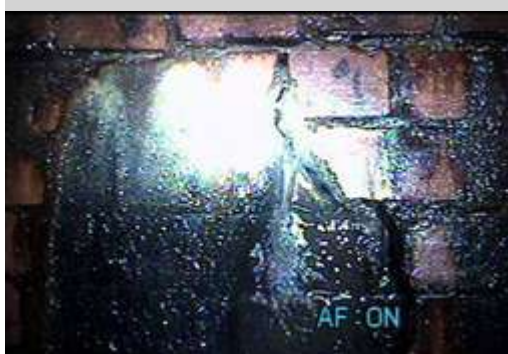
Defect 2

barrel cracked, infiltration through crack

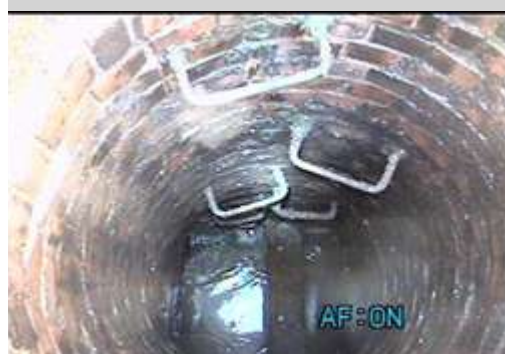
Defect 1

Count: **6** Missing: **0** ☒ **Corroded**

steps corroded
